Technical Service Bulletin

For Desktop MAX Mini Enclosure

This document applies to Desktop MAX mini enclosures (part 18003) sold before Feb/1/2016.

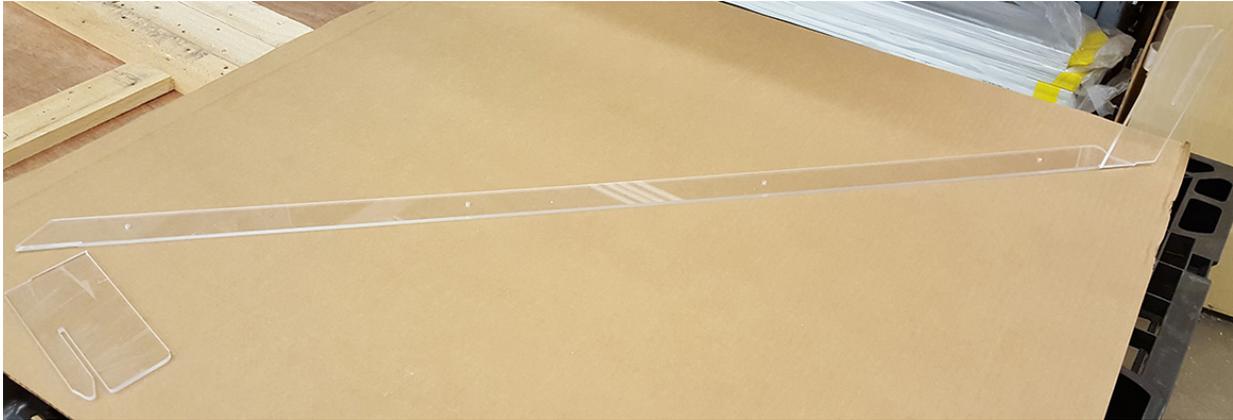
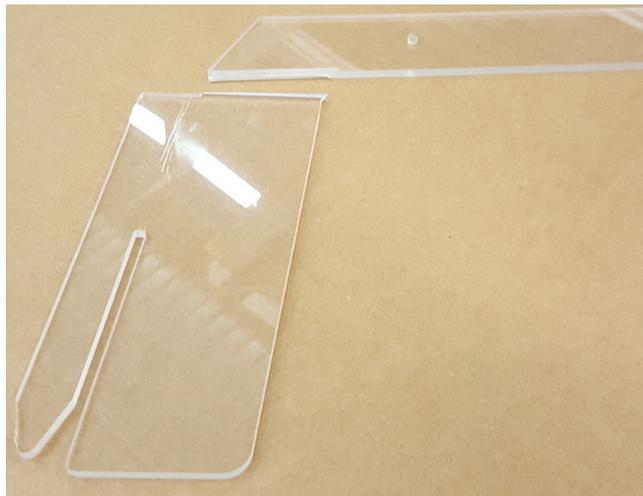
An issue has been found that may lead to the left flange on the front enclosure piece to break off of the Desktop MAX Mini Enclosure.

When failure might occur: when the machine is moved all the way toward the negative in both the X and Y axes with the dust foot installed and the door to the enclosure installed, it can place a large amount of stress against the door of the enclosure. Since there is nowhere for the door to move with it installed in place, the flange on the front of the enclosure may break off. Note that the machine would have to move both axes of the machine past the normal home zero position by over 3/8" for this to occur (possible, but uncommon during most normal operations).

To resolve this problem, the front piece of the mini enclosure has been redesigned to allow for more room for the dust foot. As a result, the left and right sides of the enclosure also had to be redesigned to work with the new front. The door and rear pieces of the enclosure are unchanged.

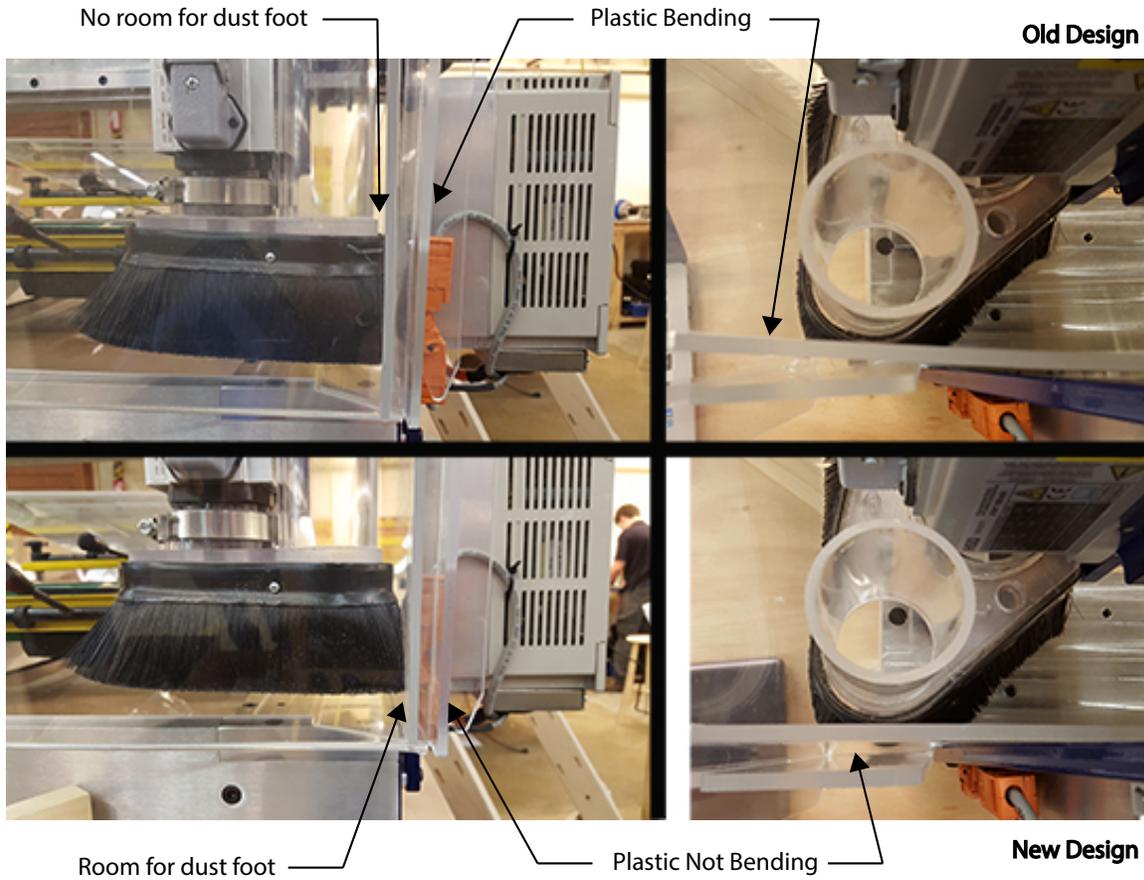
This image shows a comparison of the dust foot interacting with the mini enclosure at the limits of the machine travel. Note the flexing of the plastic of the mini enclosure in the top part of the image. The bottom part of the image shows the revised design of the enclosure, which eliminates the stress on the enclosure.
